The Effects of Plastered Skin Confinement on the Performance of Straw Bale Wall Systems

Adrienne Wheeler, David Riley and Thomas Boothby
Pennsylvania State University

Summer Research Opportunities Program 2004

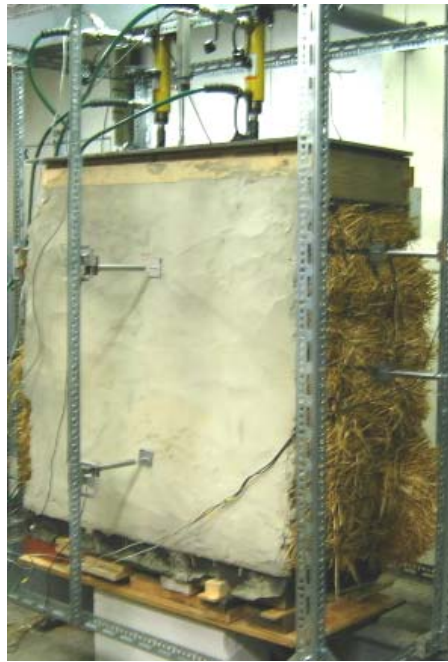
4.2a

Figure 4.2- Unconfined(a) and Confined(b) test specimens

Laboratory test conducted by David Riley and students in 2003-2004, at Pennsylvania State University, showed some of the benefits to confining plaster skins. In this program, they tested walls with moderately confined skins and walls with completely confined skins. The test specimens were four feet long three bales high plastered straw walls. The bales were pinned with rebar, sandwiched in 17-gauge wire mesh using pins, and plastered with cement stucco. Each wall had top and bottom box beams placed on them that were strapped to the bales with polypropylene strapping. On the top of the upper box beam laid a steel plate to evenly distribute the load to the bales. The entire specimen rested on a bottom plate that had threaded rods connected to the floor. The stucco was confined with Z-channel on the top of the skin and J-channel on the bottom. The confined specimen had additional 2x6 and 2x4 battens along the top and bottom of the plaster skins (Figure 4.2a). The other specimen did not have the extra batten on the bottom of the skins for support (Figure 4.2b), so the skins rested solely on the J-channel. Two 20 kip hydraulic pumps electronically applied the load pressure to the walls. Both specimens under went compression tests. The testing frame to which the specimens were hooked up comprised of the potentiometers three along either side and two, front and back. Strain gauges were also placed vertically along the front and backside of the wall.

During the compression test with moderate confinement the total wall system withstood about 7,000 pounds, and the skins vertically sheared off the lathe. In the first case of complete confinement the wall failed at about 16,000 pounds and the skins remained in place with minor cracking. This specimen also continued to fall forward as greater load was applied. The second fully confined specimen tested did not reach failure in the lab. At a load of 20,000 pounds the specimen incurred little cracking in the plaster, and stood perfectly erect. The second specimen compares quite well with the highly reinforced specimen in Cale Ash's test which withstood 19kips.

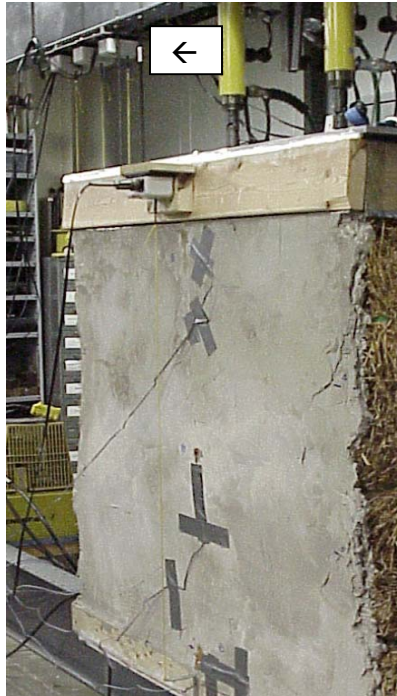
Figure 4.5 potentiometers attached to testing frame

The potentiometers connected to the wall specimen in the completely confined test incurred technical difficulties. Before the test began it was hypothesized that the bottom potentiometers would receive the biggest recording of deflection, since all loads were being applied from the top of the wall and transferring downward.

It was also assumed that the wall would hold more than the wall with moderate confinement. The middle potentiometers did not give any recording of data on either side of the wall, which would infer there was no deflection in the center of the bale. This conclusion however is unreasonable to assume due to the unlikely hood of a wall deflecting on the top and bottom with out going through the center. The illogicality of the graphs is explained by the potentiometers being secured to the testing frame and not the actual test specimen (Figure 4.5). This setup allows for the potentiometers to record the movement of the frame in addition to the deflection in the wall, which is not what researchers were looking for in this test. To address this issue, the
